DIRECT CLUTCH Services

Shanked bolt PDF

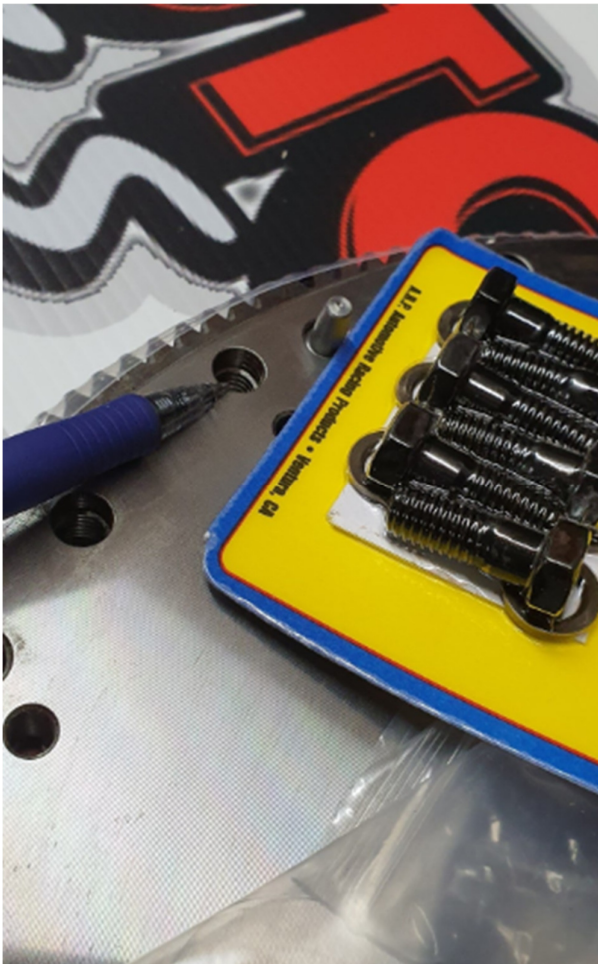
*Special note: Many of the older flywheels do not run modern style dowels. Instead these units required a bolt with a specific shank. Failing to run these correct shank bolts will result in an imbalance, by allowing the clutch cover to move off centre and potential clutch explosion at higher RPM! Very dangerous!

Pic 1: the shanked hole can be seen in this flywheel....and the corresponding shanked bolt in pic 2:

This ensures complete accuracy when fitting the old non doweled clutch covers.
